Manhole Inspection Summary

Manhole # S33EE_062MH

Location Address: **19 PRESTON ST**

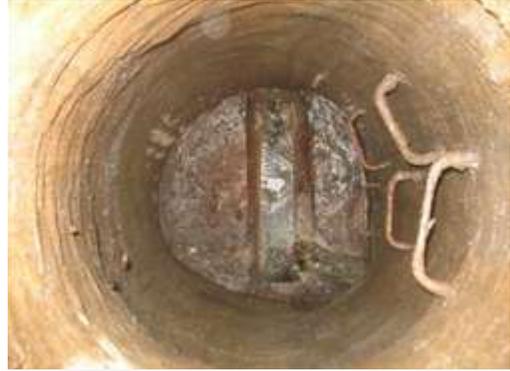
Top View

Adjustment infiltration. Corroded steps. Evidence of surcharge - Bench debris.

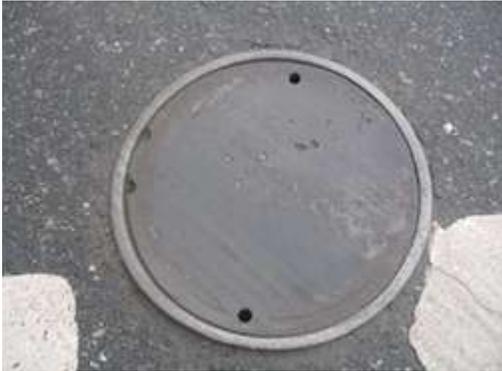
Defect

Worn cover.

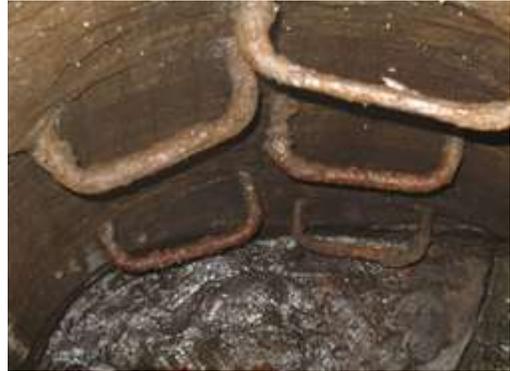
Defect

Corroded steps. Evidence of surcharge - Bench debris.

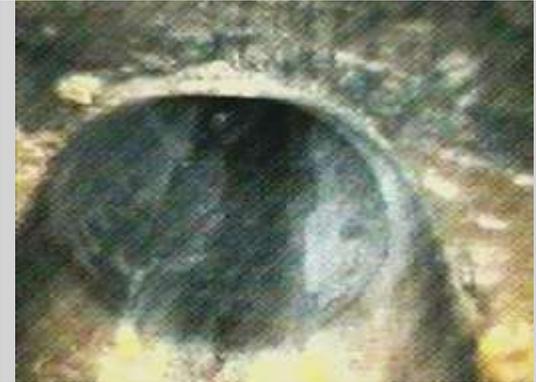
15 in. Circular Gravity Sewer
Pipe Out @ 12 O'Clock

Deposits: None Mud Sludge **Debris** Grease

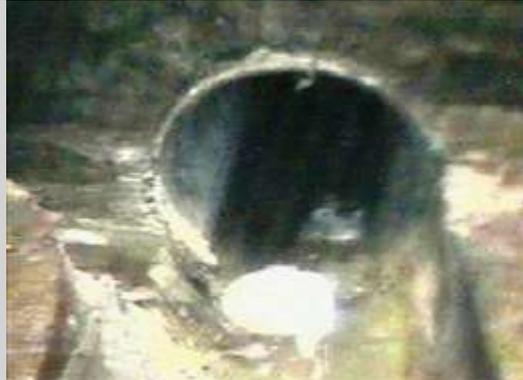
16 in. Circular Gravity Sewer

Deposits: None Mud Sludge **Debris** Grease

Silt Depth: **0** (in.) Deposits Extent: **Light**
